A Study of Stability Problems and Hazard
Evaluation of the Kansas Portion of
The Tri-State Mining Area

J R McCauley, L L Brady, and F W Wilson
Kansas Geological Survey Open-File Report, 83-2

A mining research contract report
JANUARY 1983

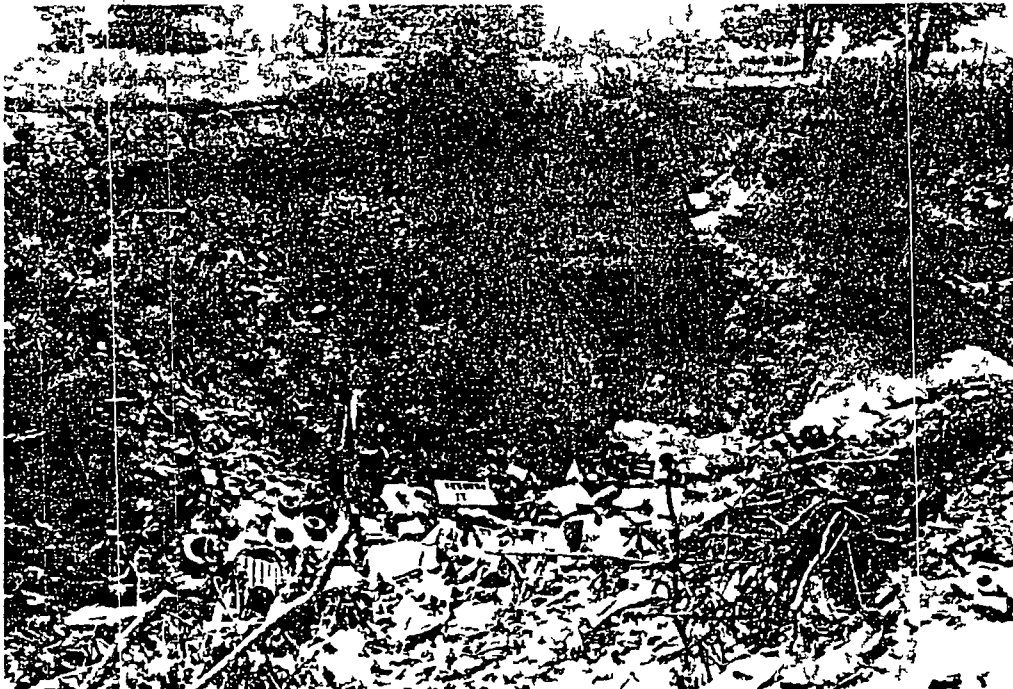
FIGURE 4 - Collapsed shaft No 2 in sec 22, T 33S R 25E
east of Crestline Kansas

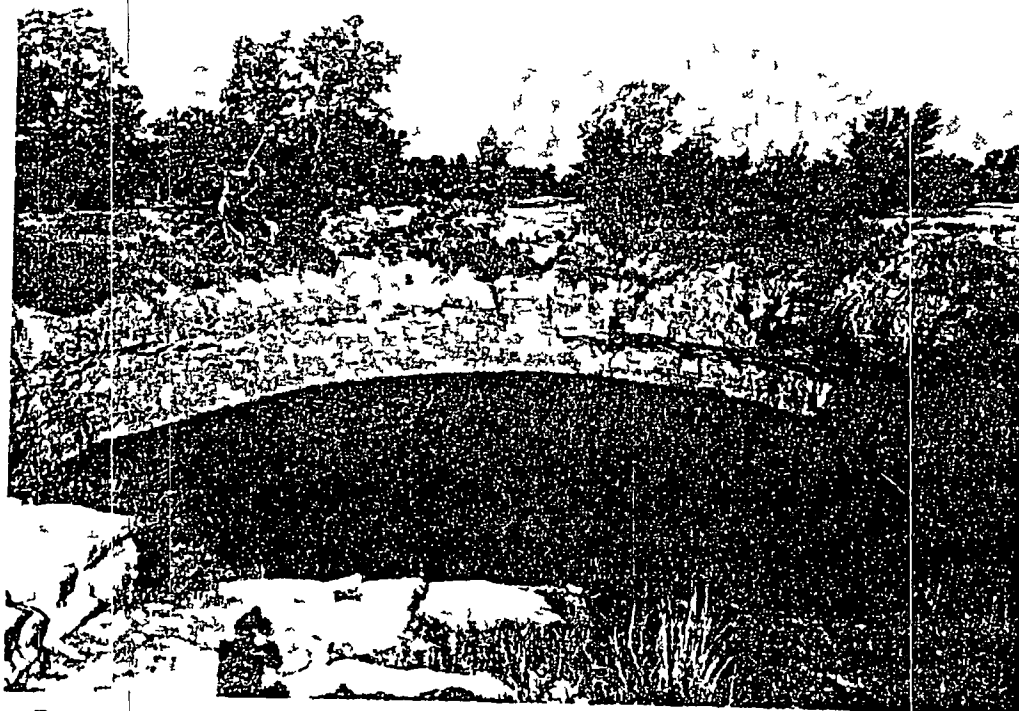
Figure 6 is another large collapse which is number 2 in section 11 T 35S R 23E This collapse is about 55 meters (180 feet) in diameter and is filled with water to within 12 meters (40 feet) of the surface Its total depth is unknown, but mine workings are about 90 meters (300 feet) deep Another large collapse is number 1 in section 7 T 35S R 24E This oblong-shaped collapse is 46 meters (150 feet) by 90 meters (300 feet) and 18 meters (60 feet) deep It occurs within 90 meters (300 feet) of U S highway 69 and is over mine workings which are 90 meters (300 feet) deep Small shallow subsidences occur just to the southeast of this large collapse that may indicate its direction of growth

FIGURE 6 - Surface collapse 2 in sec 11 T 35S R 23E northwest of Treece Kansas

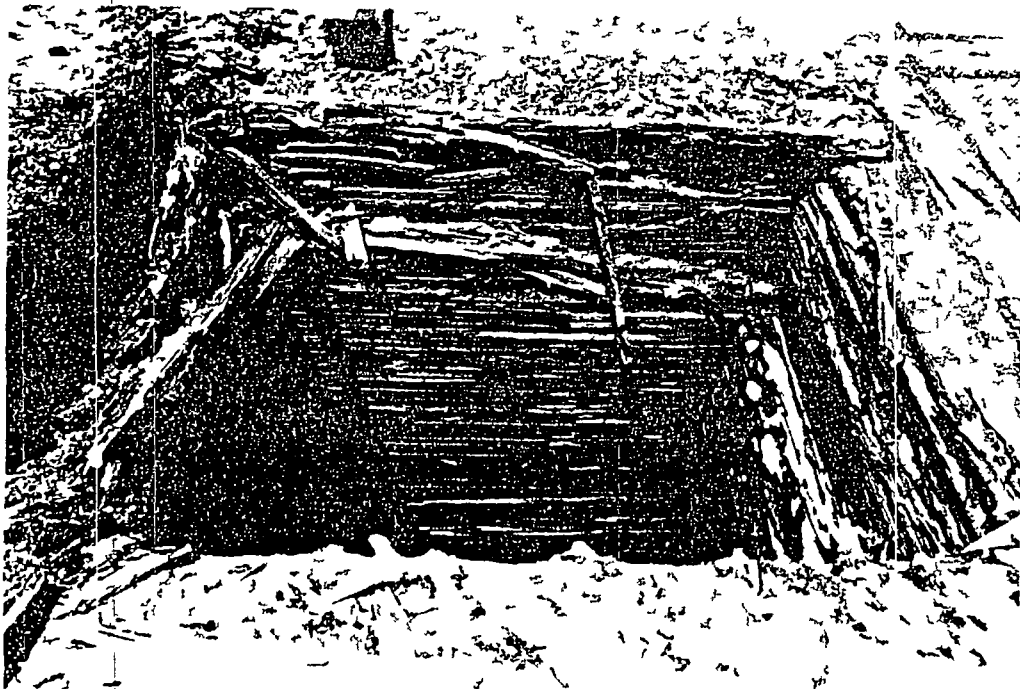
FIGURE 8 - Open uncollapsed shaft No 6 in sec 2 T 35S
R 23E north of Treece, Kansas

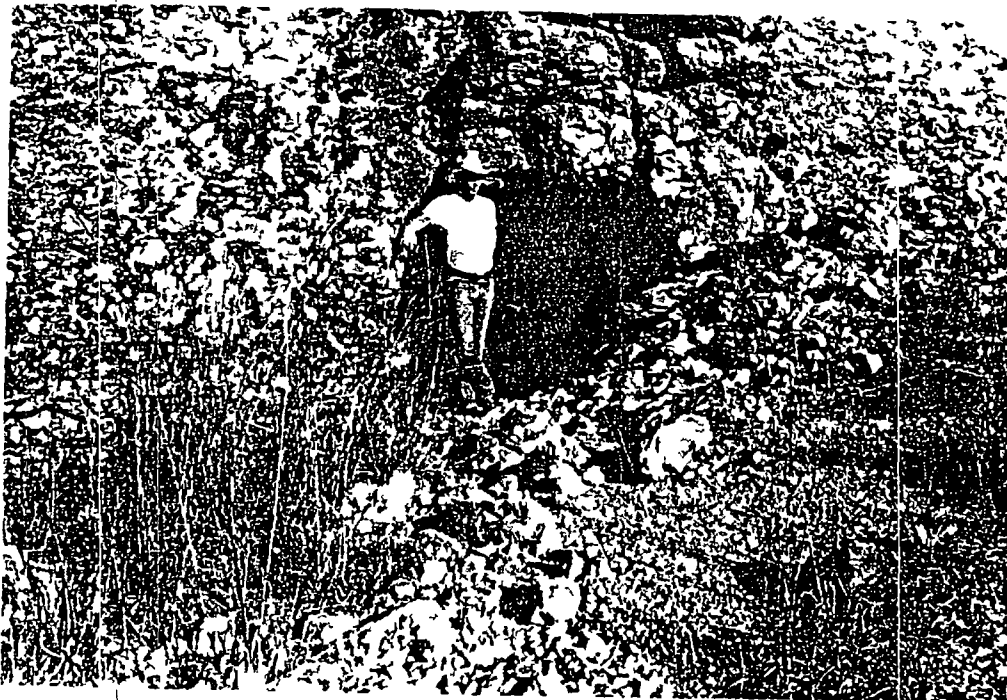
Six adits were found in the Galena area all of them are located in section 27. Figure 18 shows an adit (number 79 Figure B-1^c) located near a county road southwest of Galena. Most adits are partially flooded and none were entered.

FIGURE 18 - Adit No 79 in sec 27 T 34S R 25E , southwest of Galena, Kansas

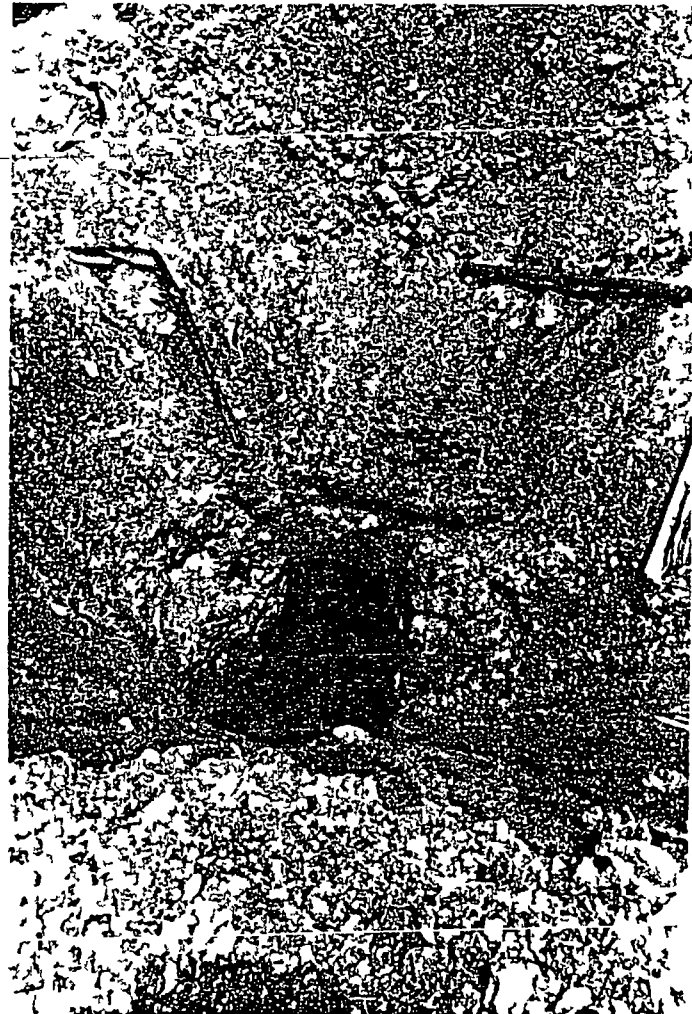
FIGURE 20 - Collapsed shaft and shallow mine room in Galena Kansas sec 14 T 34S R 25E
